# Estuarial and coastal: Canal do Fundão remediation, Rio de Janeiro, Brazil

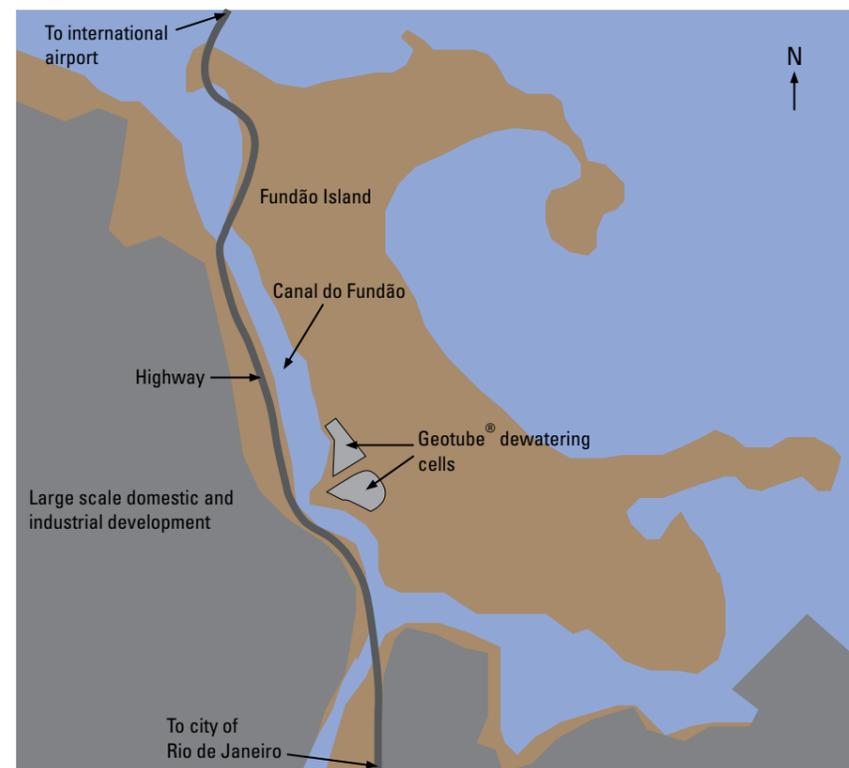
Layout of Canal do Fundão

Canal do Fundão is a 6 km long artificial estuary formed in the early 1950's when the Brazilian federal oil company (Petrobrás) conducted a large land reclamation project to connect 8 near-shore islands adjacent to the Eastern shore of Guanabara Bay in the state of Rio de Janeiro to form Fundão Island. Over time sediment has built up in the canal and it has not been able to self-flush for the last 20 years.

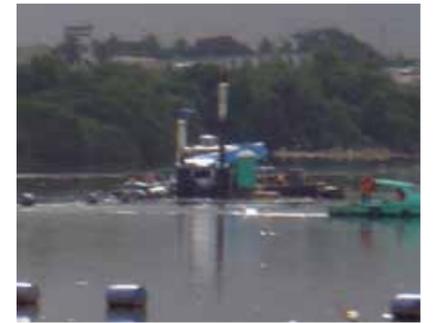
Dredging contaminated sediments in Canal do Fundão

To make the canal self-flushing required the dredging of 2 million m<sup>3</sup> of sediments. Of this, 600,000 m<sup>3</sup> was considered to be contaminated and would be dredged and then dewatered in special cells on Fundão Island. The remaining 1.4 million m<sup>3</sup> of sediments was considered to be uncontaminated and were dredged and transported to an offshore dumpsite for disposal.

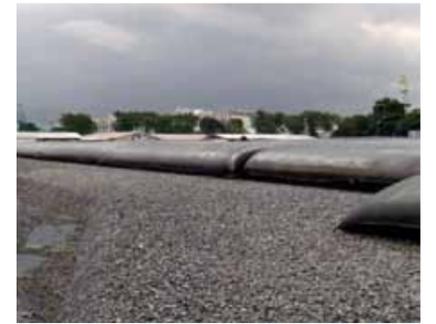
Geotube® dewatering platform

The dewatering cells were constructed using a composite base liner over which was placed a 200 mm thick gravel drainage blanket. The dredged contaminated sediments were pumped to the designated dewatering cells where it was distributed to the Geotube® dewatering containers by means of a manifold system. The Geotube® containers installed had a circumference of 36.6 m with lengths varying to fit the geometry of the dewatering cells. The chemical dewatering accelerant was injected into the manifold system with the dosage

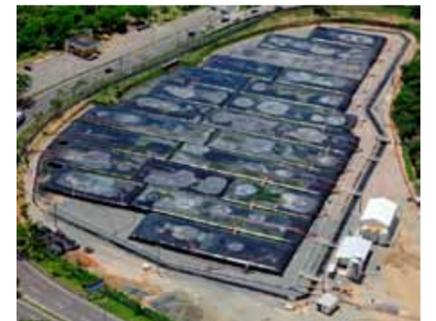
One of the Geotube® dewatering cells

The control filling height of the Geotube® dewatering containers was 2.4 m. When the control filling height was reached, filling would be discontinued and the Geotube® dewatering unit allowed to drawdown under gravity flow. The incoming slurry stream would then be diverted to fill other Geotube® dewatering units through management of the manifold valve system. This filling and drawdown cycle was repeated a number of times until a final dewatered filled height of 2.1 m was obtained. The operation was conducted 24 hours per day, 6 days per week. The effluent from the Geotube® units was collected in the under-drain system of each of the dewatering cells and discharged directly into Canal do Fundão. Effluent quality was continuously monitored to ensure that it met Brazilian Federal discharge standards. Each dewatering cell finally contained three Geotube® layers to handle the dewatering of the contaminated sediments volume.

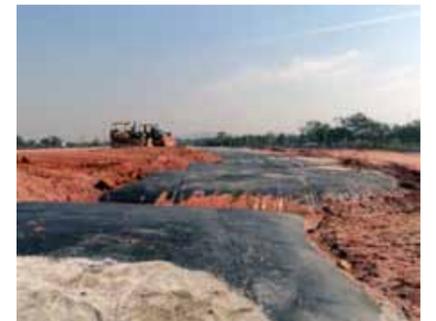
Capping a Geotube® dewatering cell

Once the dewatering of the contaminated sediments was completed each dewatering cell was capped with an earth covering and then a barrier system was constructed over the top of each cell. Finally, the capped mounds were vegetated and they now form part of the natural landscape of Fundão Island.

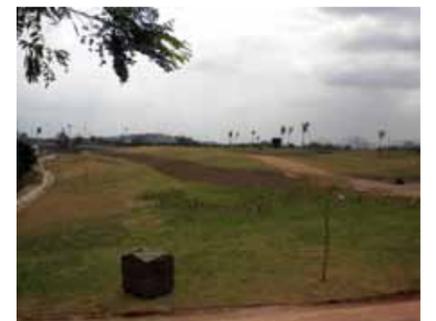
Capped and vegetated dewatering cell
