## Geotube® Shoreline Protection at Round Lake, Ontario

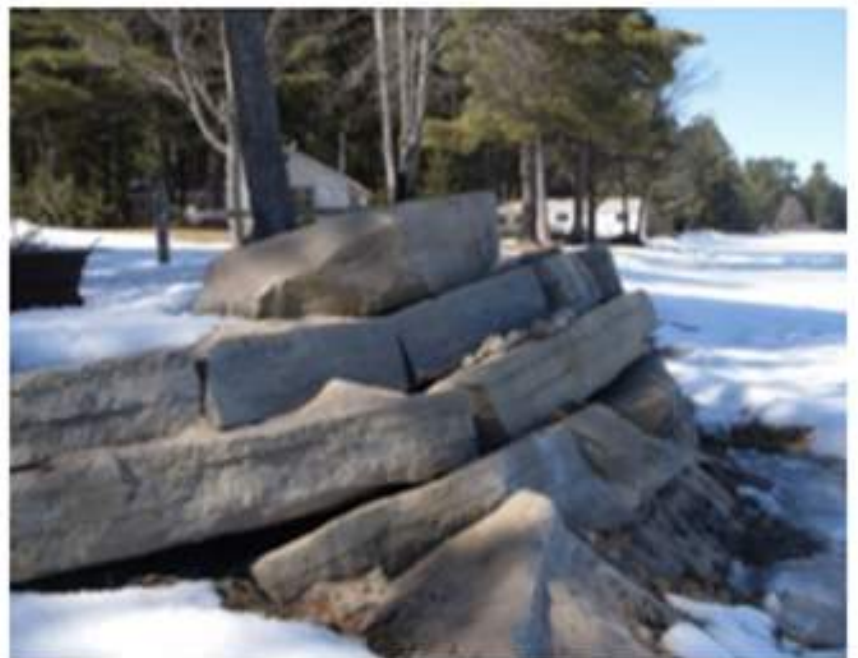
*Photo A-1*

As seen from photo (A-1) the ice warps the structures out of position, damaging the surrounding area.

Winters have been hard times for the cottagers of Round Lake, Ontario. Ice damage has become detrimental to waterfront properties causing erosion and ice destruction. Typically cottage owners would install stone barriers, timber or steel bulkheads and other solutions to combat this problem. This has proven ineffective - the structures simply can't withstand the severe ice push.

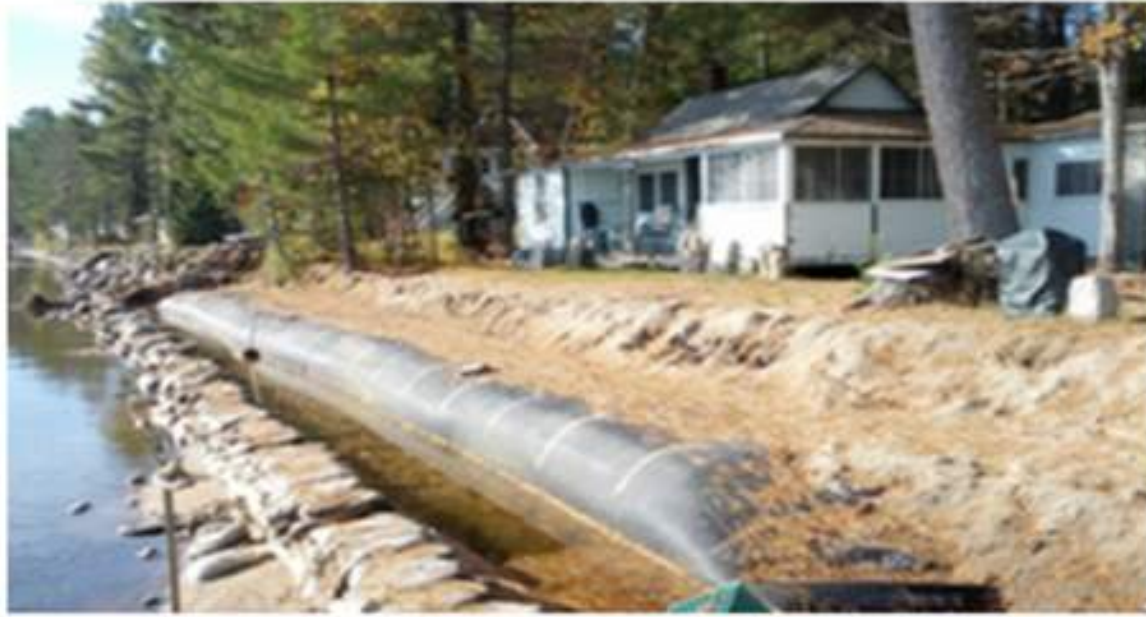
*Geotube® Installation in Fall of 2013*

The Geotube® was filled with 100 cubic yards of sand. A thick Geo-synthetic was then put on top of the Geotube® to protect it from debris. A scour apron was then added to ensure wave action would not erode under the Geotube® and a small anchor tube was then added to keep the apron in place.

Covering the Geotube® in sand allowed for the structure to blend in with the surrounding area and be aesthetically pleasing. When filled with sand, the Geotube® became a monolithic structure - 100 feet long, three and a half feet high and almost seven feet wide. In comparison to other shoreline protection technology, the Geotube® is immune to weather and erosion. The sloping design of the structure not only allows for the Geotube® to blend into the surrounding area, but also provides deflection of ice as it pushes up against the container.

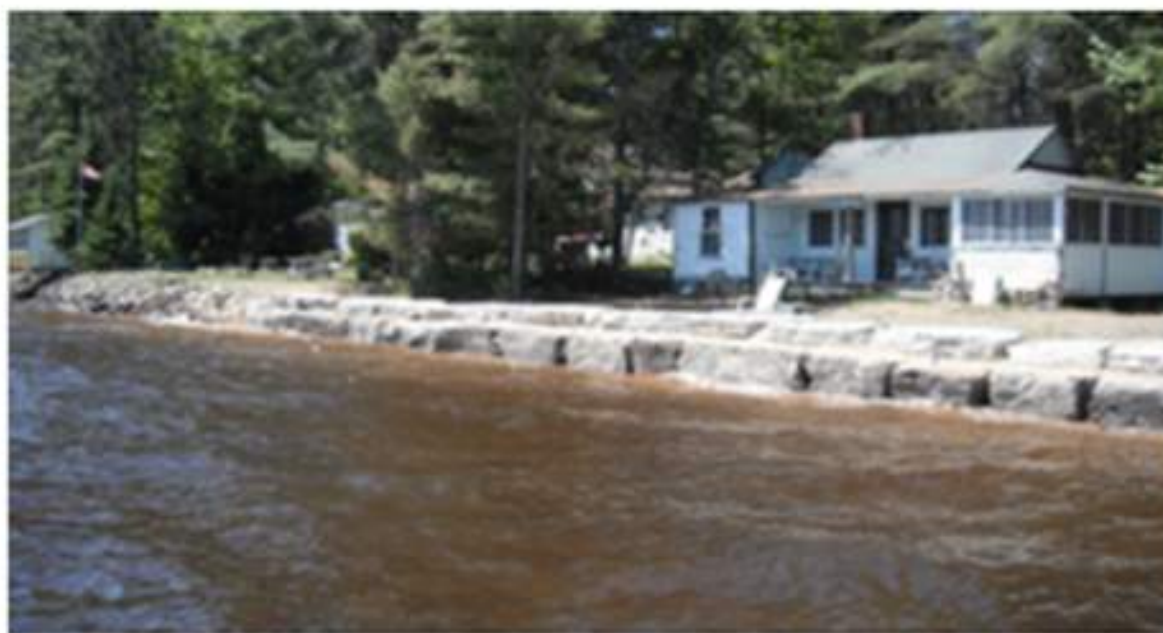
*Shoreline in June 2014 . No movement was visible in the Geotube or the Armour stone that covers it.*

Nearly a year on, the Geotube® constructed at Round Lake has proven a complete success. The owner observed no movement in the Geotube®.
