Case study:

Simplifying arsenic sludge management at a gold mine

- Bishop Solids Management Solution
- Sludge collection, dewatering and storage
- Western Canada mine site

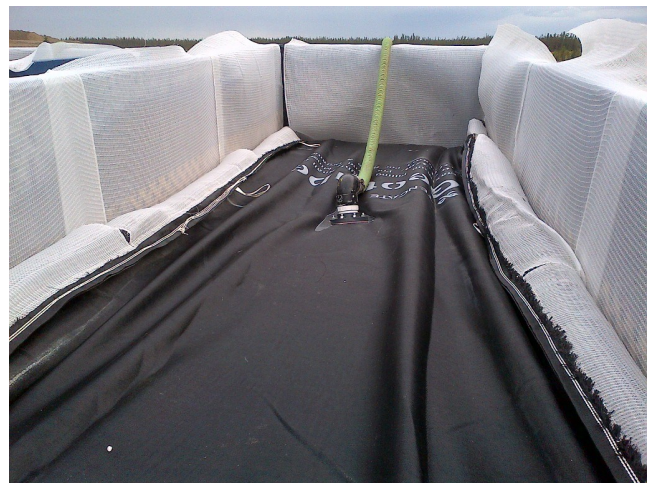
Two Geotube containers are set up in roll-off bins to collect and dewater the arsenic sludge. Once full, operators can easily move the bin to an onsite storage area, tip out the Geotube then quickly replace it with a new one.

About every 12 hours, accumulated sludge is pumped from an 88m³ mix tank to one of two Geotube containers that are set up inside roll-off dewatering bins.

Once a Geotube container is full, it is transported in the roll-off bin to an area in the tailings facility where it is left for permanent storage. After dumping the Geotube container, the bin is returned to the mill and the bag is easily replaced.

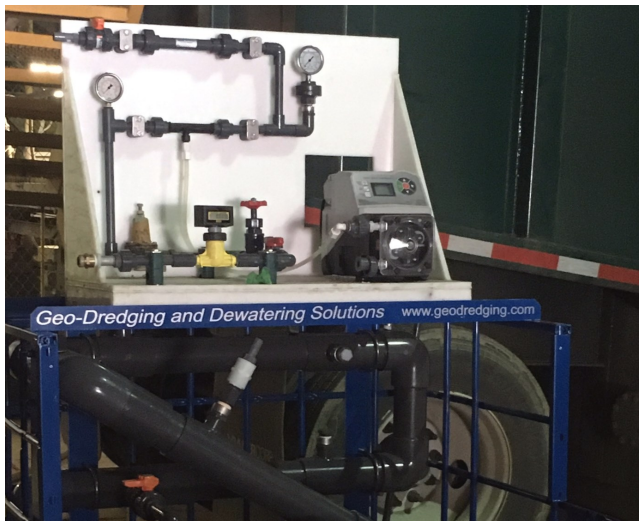
The automated VEPAS eliminates mixers and aging tanks, making the polymer system easy to use and maintain.

As the sludge is pumped, Bishop Water's non-mechanical VEPAS (Venturi Emulsion Polymer Activation System) adds the optimal dose of polymer directly into the feed line to accelerate dewatering and retain solids.

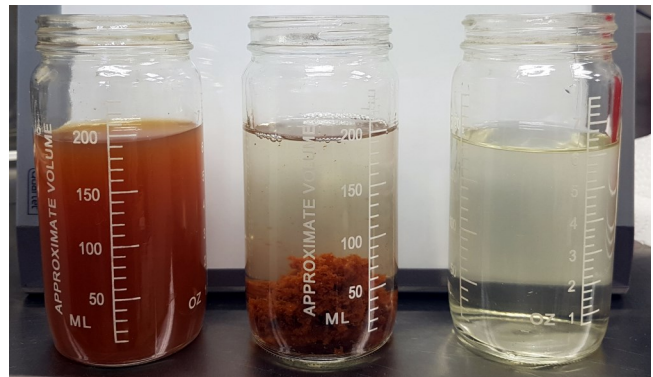
Jar testing shows the results of the simple, low-energy Bishop Solids Management Solution. From left: A sample of the sludge backwash from the MF system; solids clump together after polymer addition; clear filtrate is released from the Geotube container.

Clear filtrate is released from the pores of the Geotube and is pumped to another tank for testing prior to release. An operator verifies that the arsenic level of the filtrate is below the regulatory limit of 10 ppb (0.01 mg/L) before it is released to a pond that empties into a creek.
