Case Study

| application | Lagoon Cleanup |
| location | Dundee, Oregon |
| product | Geotube® Dewatering Technology |

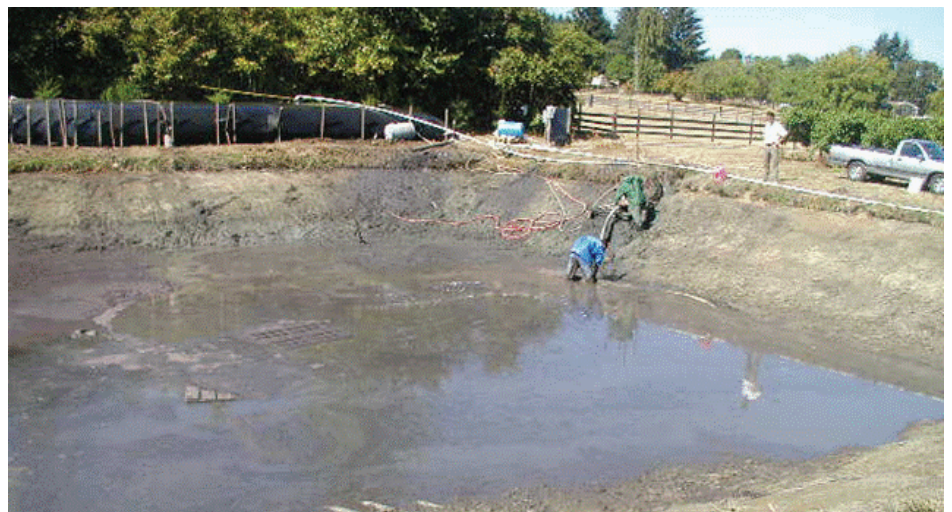
Figure 1. Cleaning the lagoon with Geotube® unit in the background.

system. The first order of business, however, was to clean out the winery’s lagoon before creating the Geotube® dewatering technology/SFF water treatment system (see Figure 1).

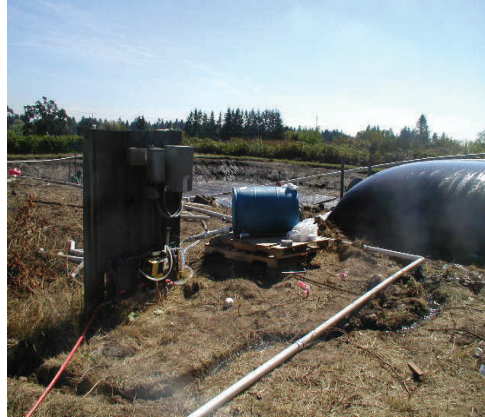
Figure 2 shows the cationic polymer metering system which injects the conditioner into a simple serpentine mixing chamber before injection into the Geotube® unit.

Figure 2. Polymer metering system with Geotube® unit.

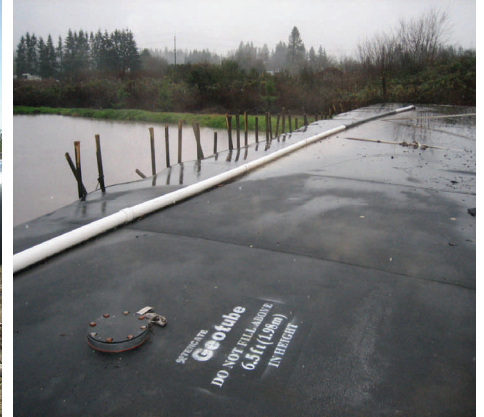
Figure 3. Filled Geotube® unit next to clean lagoon.

Figure 3 shows the completely filled Geotube® unit next to the lagoon. Figure 4 shows the cleaned lagoon with an aeration system now in place. The dewatered lagoon material will eventually be applied to the adjacent pinot noir grape vineyards.

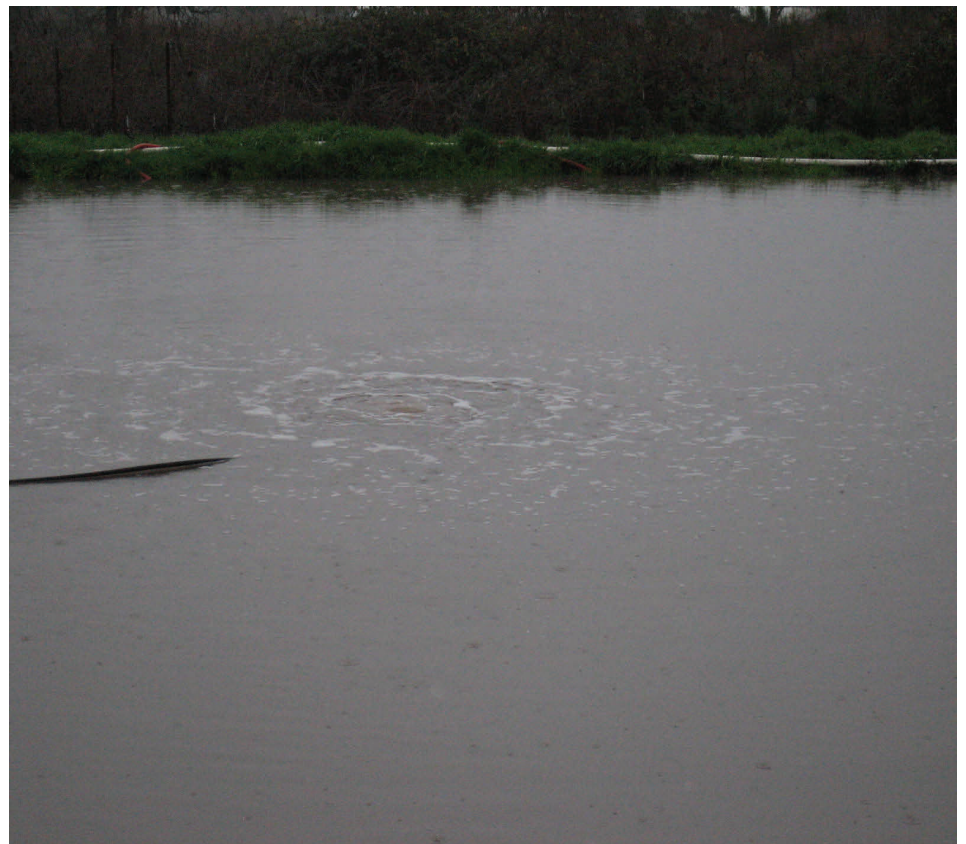
Figure 4. Aeration system providing aerobic digestion to the clean lagoon.
