## Application Story

**PROJECT** | CANCUN, MEXICO  
**Product** | Geotube® Marine Structures Technology  
**Application** | Breakwaters

**Location** | Cancun, Mexico  
**Installation** | 2006-2007

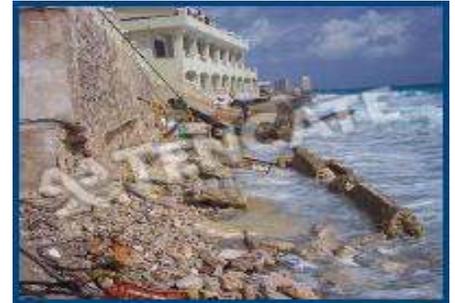
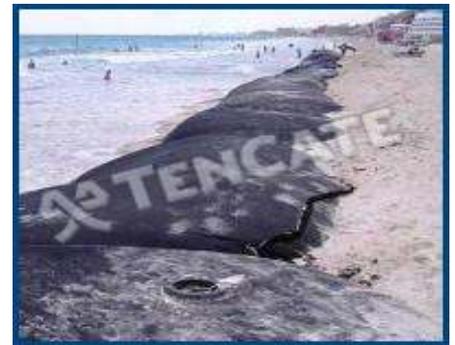
The Yucatan Peninsula of Mexico suffered greatly from the destructive forces of Hurricane Wilma in October 2005. Cancun's beaches were eroded, sea walls were devastated, and many resorts suffered extensive structural damage and flooding [photos 1-2]. Serious beach restoration efforts were needed to repair the resort community.

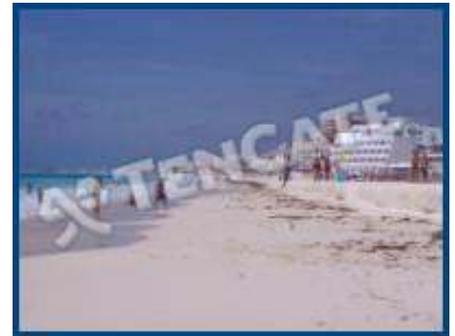
*Step One:* The plan began with the installation of Geotube® units in front of the damaged properties [photo 3]. Over 1.2 miles of containers were installed for emergency protection during the summer.

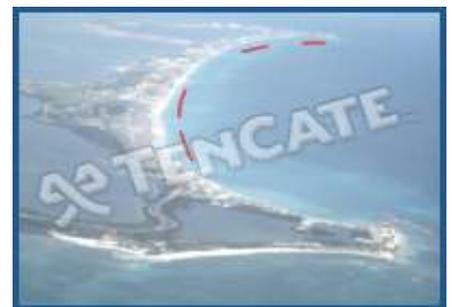
The rebuilt beaches now range from 60 to 100 feet wide [photos 4 and 7]. They are much better prepared for future hurricane seasons.
